ACCUMARK

Utility Test Hole Report - Quality Level "A"

Test Hole #: <u>8</u>	Project Numbers: <u>09-442</u>
Project Name: <u>Route 623</u>	Project Location: <u>Anywhere, USA</u>
Requested By: <u>Smith Engineering</u>	Work Type: <u>Infrastructure</u>
Point of Contact: <u>John Smith</u>	Improvements
Utility Requested: <u>Telephone</u>	Test Hole Date: <u>08-21-09</u>
Utility Found: <u>Telephone Duct</u>	Soil Conditions: <u>Moist Clay Rock</u>
Material Makeup: <u>Concrete Duck Bank</u>	Utility Condition: <u>Good</u>
Size Utility Found: <u>Duct</u>	Pavement Cond: <u>Good</u>
	<u>0.7' Asphalt</u>

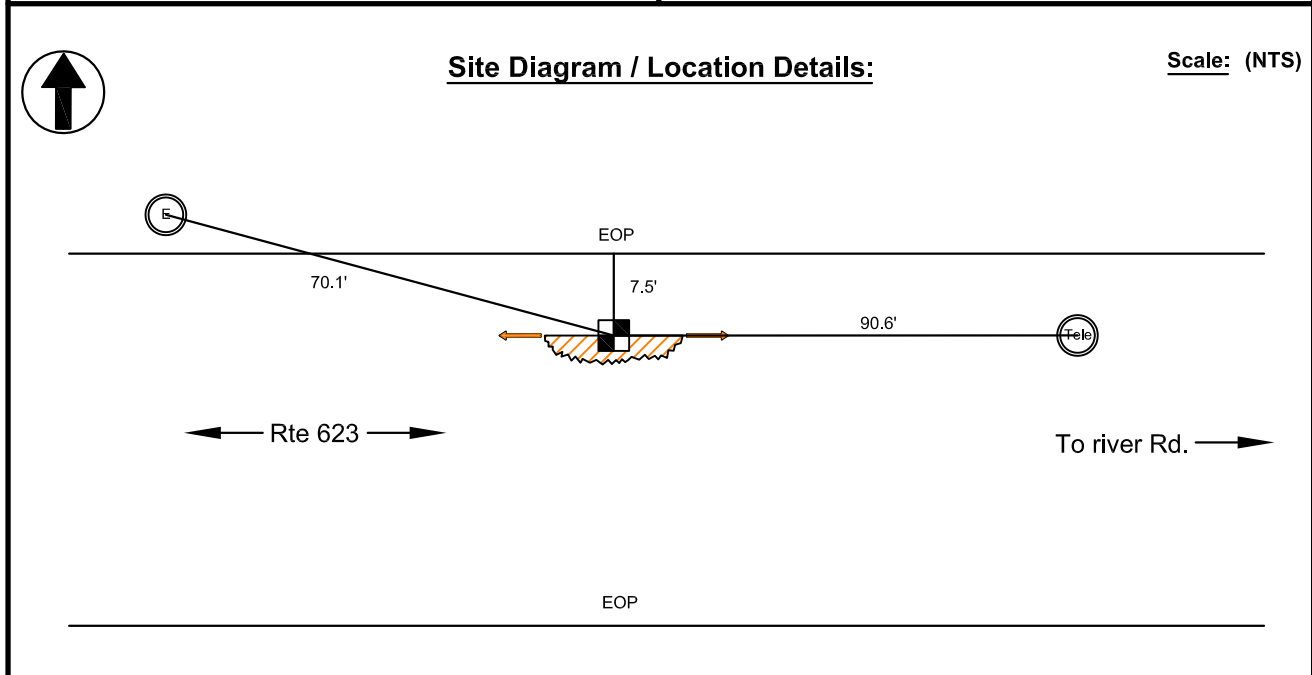
<p style="text-align: center;">Test Hole Information:</p> <p>Elevation at hub & tack / Pk: 162.87' Existing grade depth @ top of utility: 4.12' Elevation at top of utility: 158.75' Elevation at bottom of utility: 156.84'</p> <div style="display: flex; align-items: center;"> <div style="margin-right: 20px;"> <p>Cover (Top): 4.12'</p> <p>Cover (Bottom): 6.03'</p> <p>Drawn Facing: East</p> </div>

<div style="margin-left: 20px;"> <p>Existing Grade</p> <p>Utility Width: N/A</p> </div> </div>	<p style="text-align: center;">Elevation / Survey Information:</p> <p>Located By: <u>Benchmark Elevation</u> Accumark, Inc. 166.74"</p> <table style="width: 100%; border-collapse: collapse;"> <tr> <td style="text-align: center;"><u>Northing:</u></td> <td style="text-align: center;"><u>Easting:</u></td> <td style="text-align: center;"><u>Elevation:</u></td> </tr> <tr> <td style="text-align: center;">6994371.924</td> <td style="text-align: center;">11784396.304</td> <td style="text-align: center;">162.87'</td> </tr> </table> <p>Notes:</p> <p>Pk set over North edge of duct.</p>	<u>Northing:</u>	<u>Easting:</u>	<u>Elevation:</u>	6994371.924	11784396.304	162.87'
<u>Northing:</u>	<u>Easting:</u>	<u>Elevation:</u>					
6994371.924	11784396.304	162.87'
